Church of St Michaels, Mount Dinham – Interim Report for LPOW Church Roof Repair Fund

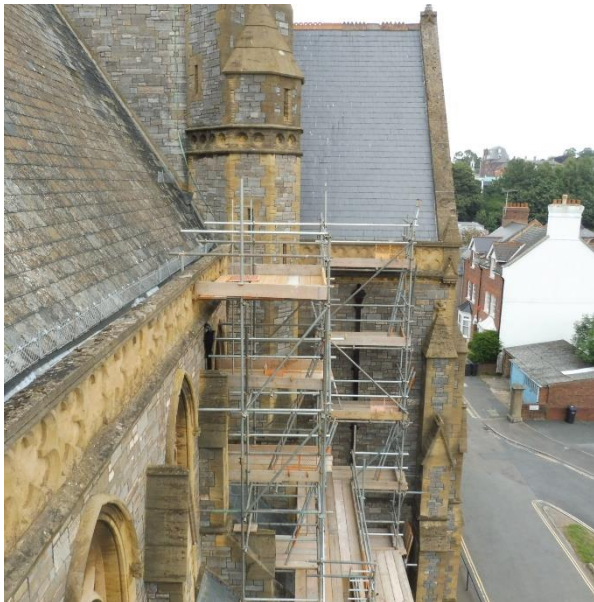
The scaffold erected along the south aisle

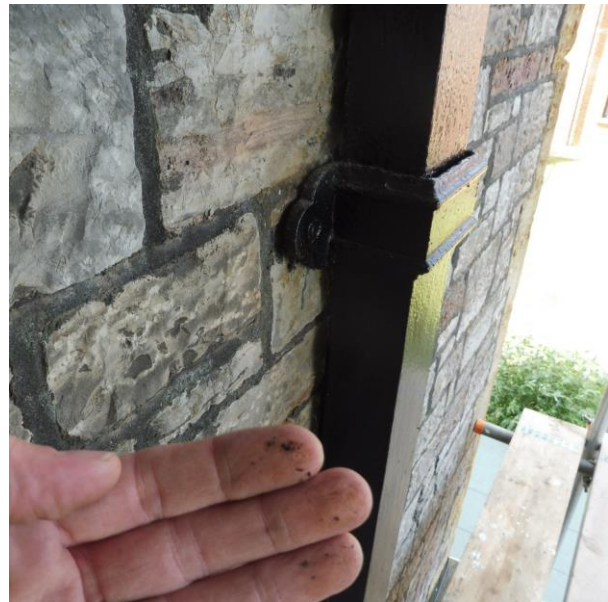
Back of this downpipe was rusted through

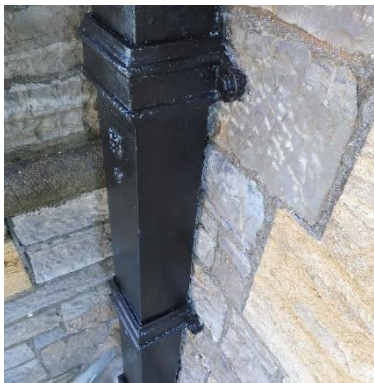
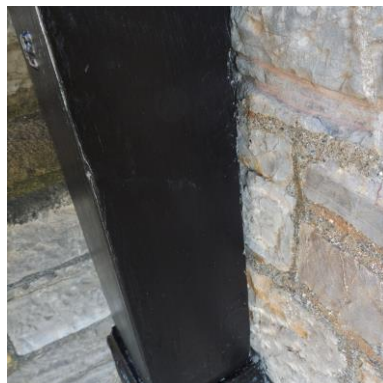
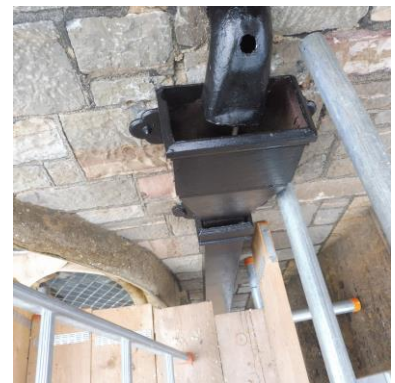
Re-decorated cast iron rain water goods.

The cast iron rain water goods were quickly rubbed back and redecorated with Keim paint which should stand the test of time for many years to come. Provisional sums were allowed for other extra over repairs to some of these rainwater goods including stand-off brackets in places where they were missing. The scaffold has been left up in certain areas for further repairs to be undertaken, where otherwise high level works are complete.

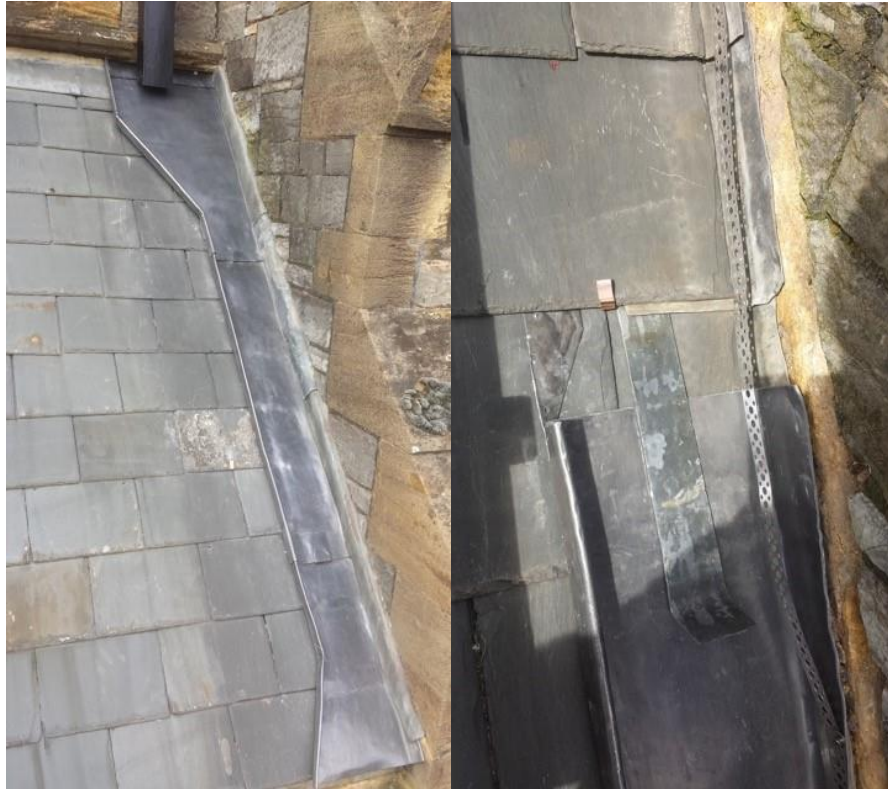
New lead 'chute' gutters over aisle roofs

Lead chute gutters have also been formed by the contractor for the aisle roofs to direct rainwater which currently runs over the slates from the high level down pipes and otherwise would present a threat to the aisles in heavy rain storms.

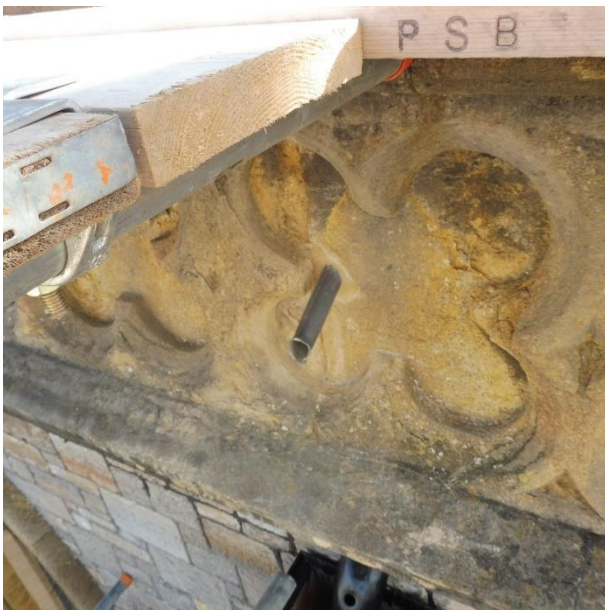
New lead drip detail from overflow gutter

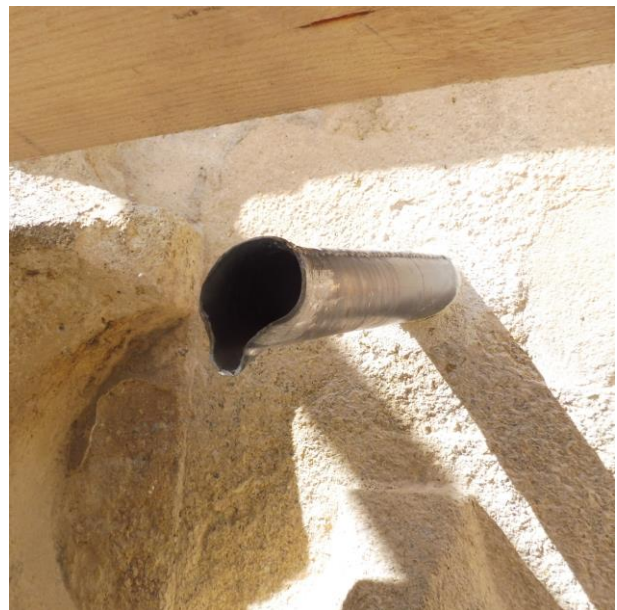
Close up of lead overflow pipe

Jonathan Rhind Architects made an early visit to discuss the detail of lead hoppers in parapet gutters where lead burning and drilling through the façade allowed an early warning overflow pipe to be installed to each hopper to mitigate problems where previously blocked gutters have caused water damage to the nave.

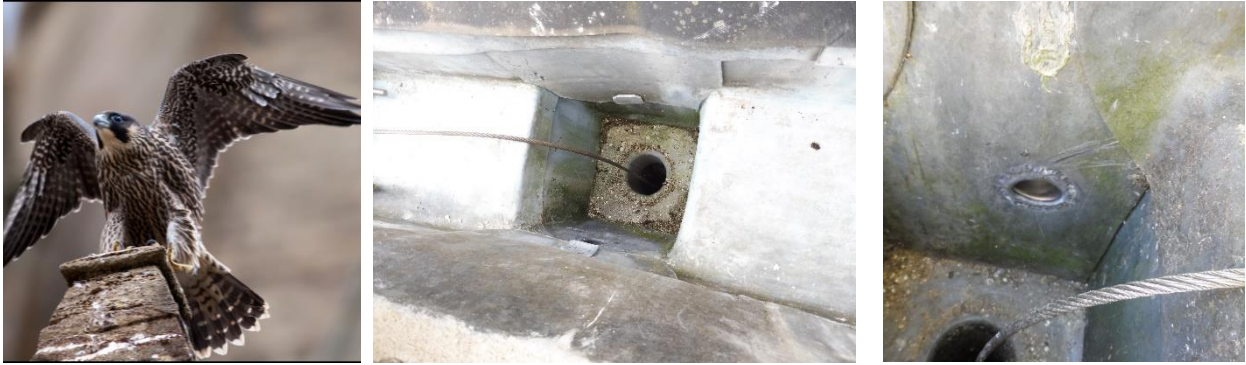
Views of lead hopper gutters with internal lead burning to the new overflow pipes – the sumps have previously been blocked by carrion dropped by the peregrine falcons.

Lead hoppers at the high level parapets had been prototyped by the contractor in discussion with Jonathan Rhind Architects. Once the method for installing these with minimal impact on the look of the façade and with hot works permits in place, the contractor was instructed to undertake all of these repairs.

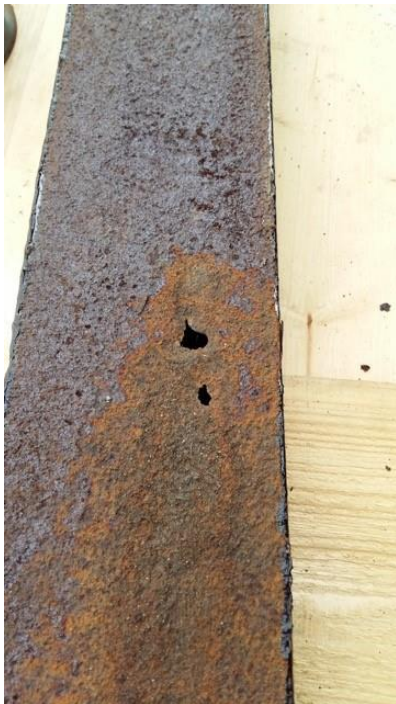
Cast iron downpipe rusted through

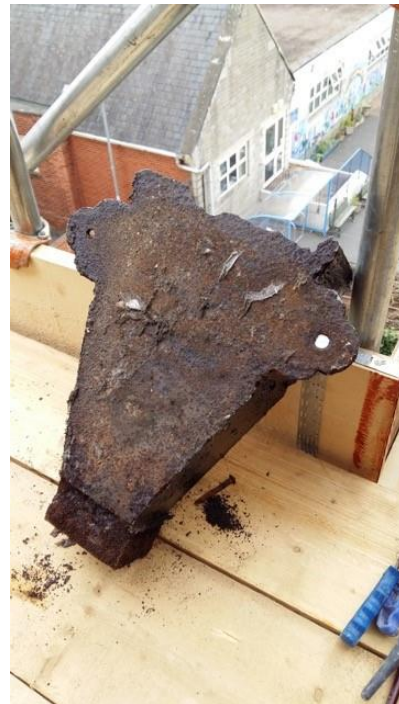
Rusted back to cast iron hopper
